European Maritime Safety Agency

**Double Hull Tankers:  
High Level Panel of Experts  
REPORT**

3<sup>rd</sup> June 2005

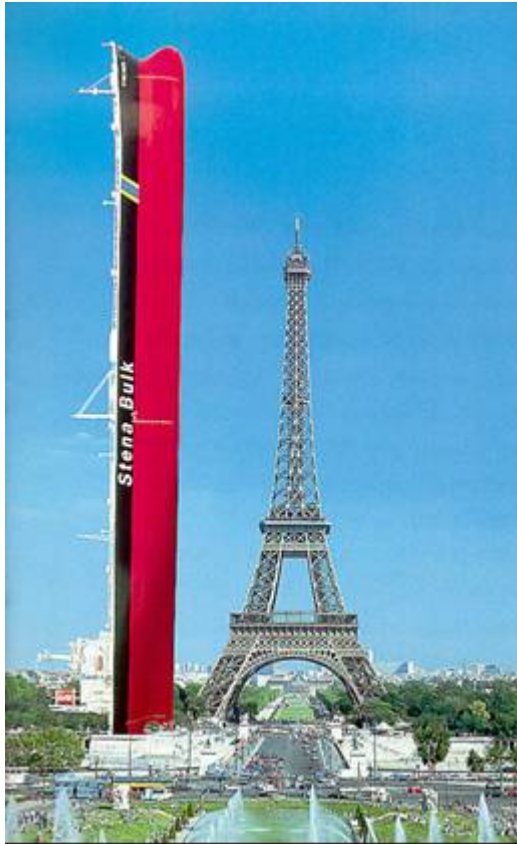
**Large tankers have many internal spaces containing complex structure**

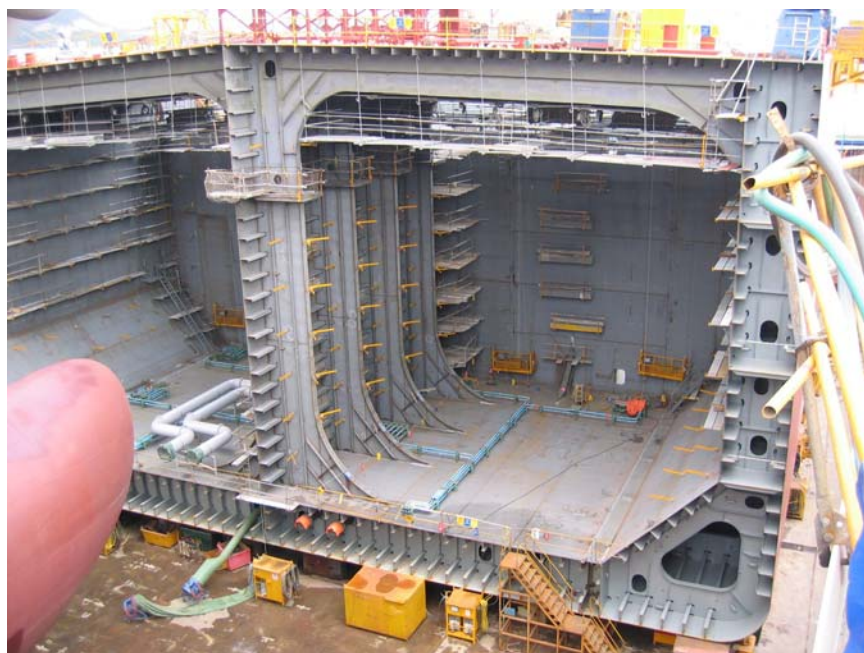
The ballast tanks have been coated during the block stage (grey), the cargo tanks have not yet been coated (structure still in prefabrication primer):

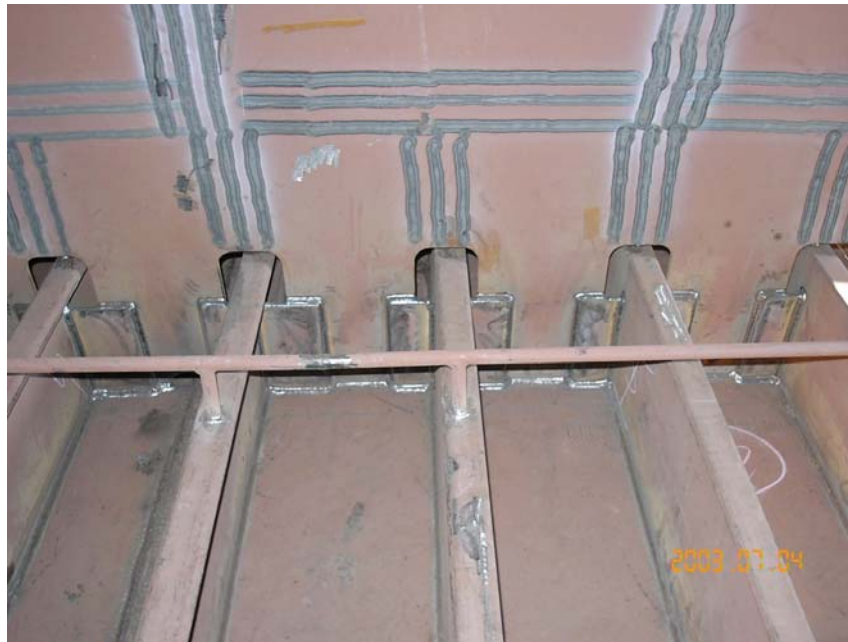
Steelwork preparation prior to cleaning and application of coating:

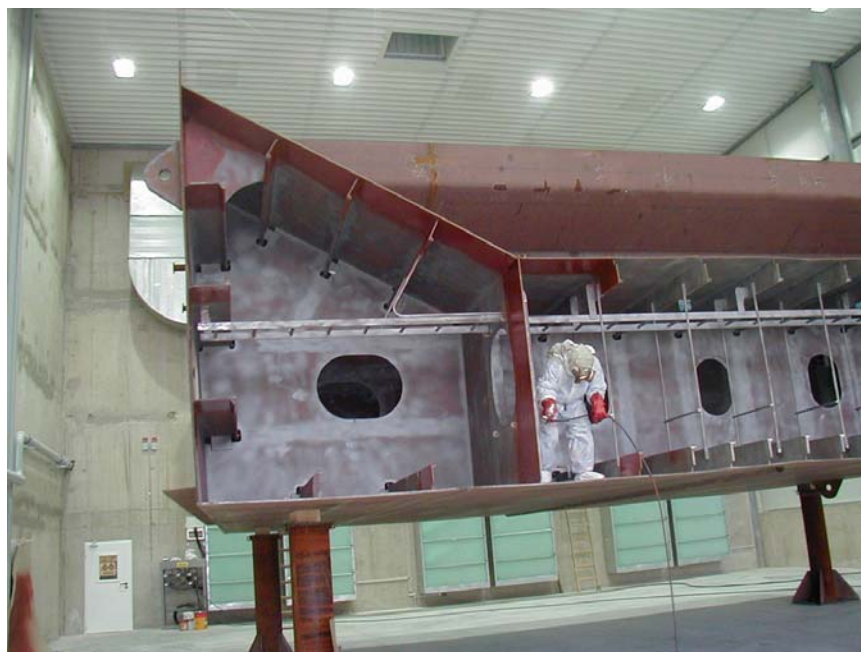
Surface preparation on a side tank block prior to application of protective coating (block steelwork with red prefabrication primer undergoing sweep blasting):

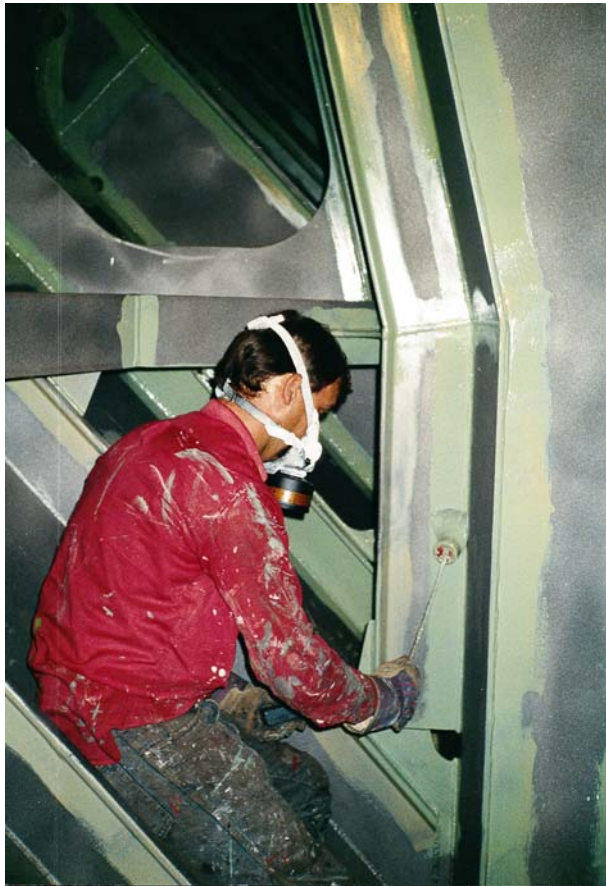
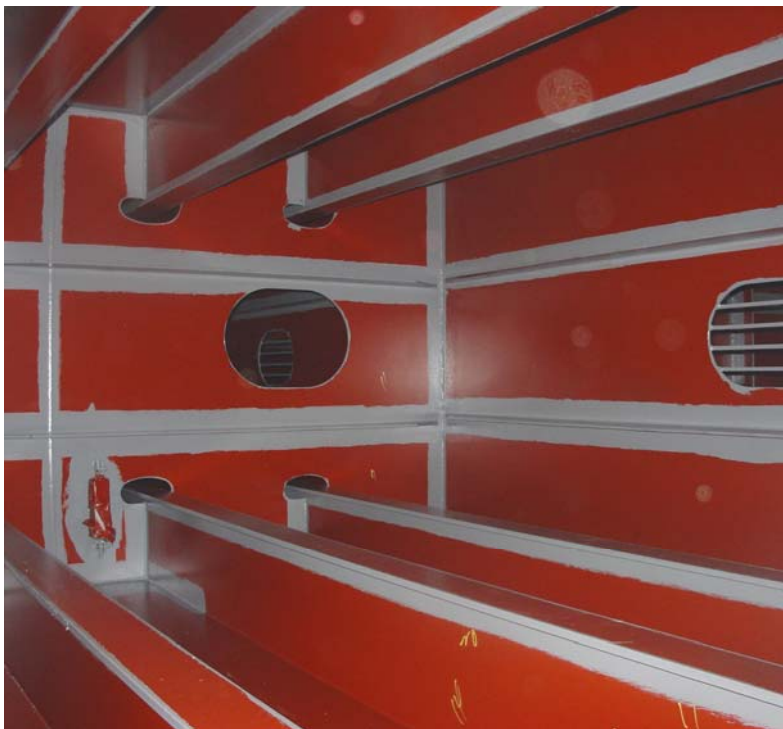
Manual stripe coating of vulnerable areas and locations that are difficult to spray after first coat and prior to application of the final coat (to ensure adequate film thickness):

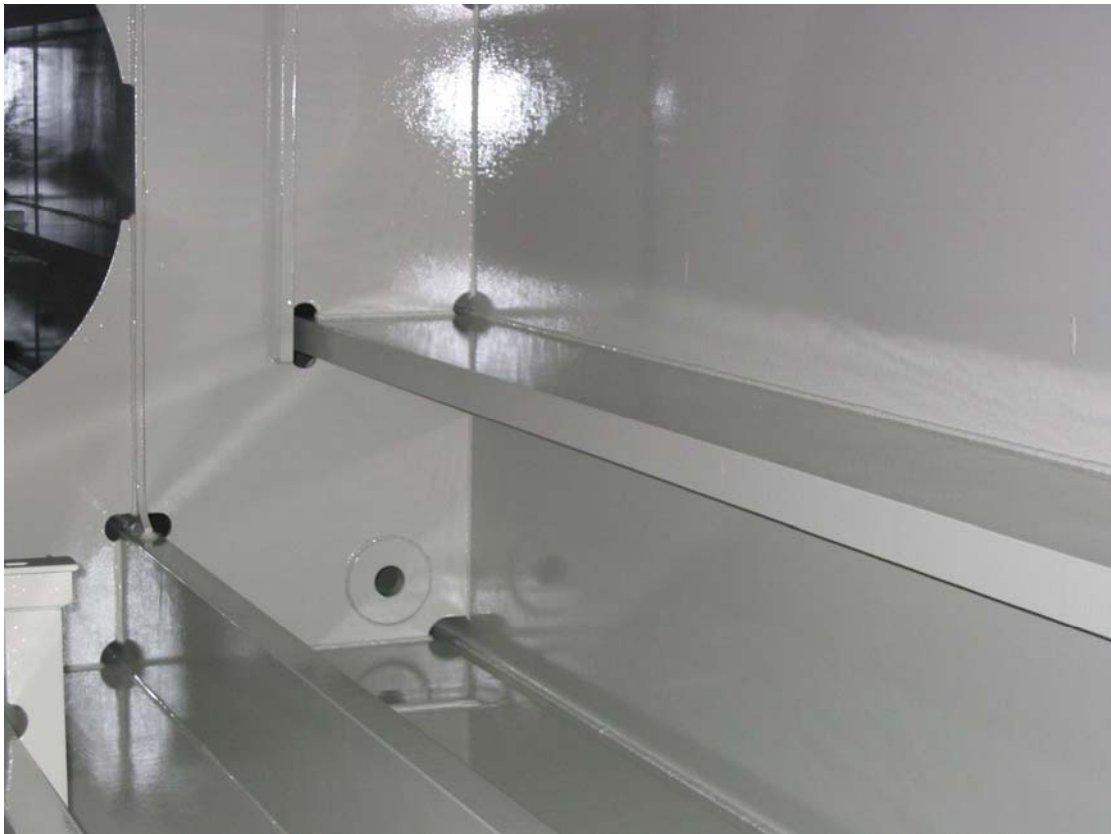
Internal structure in a double bottom tank after coating:

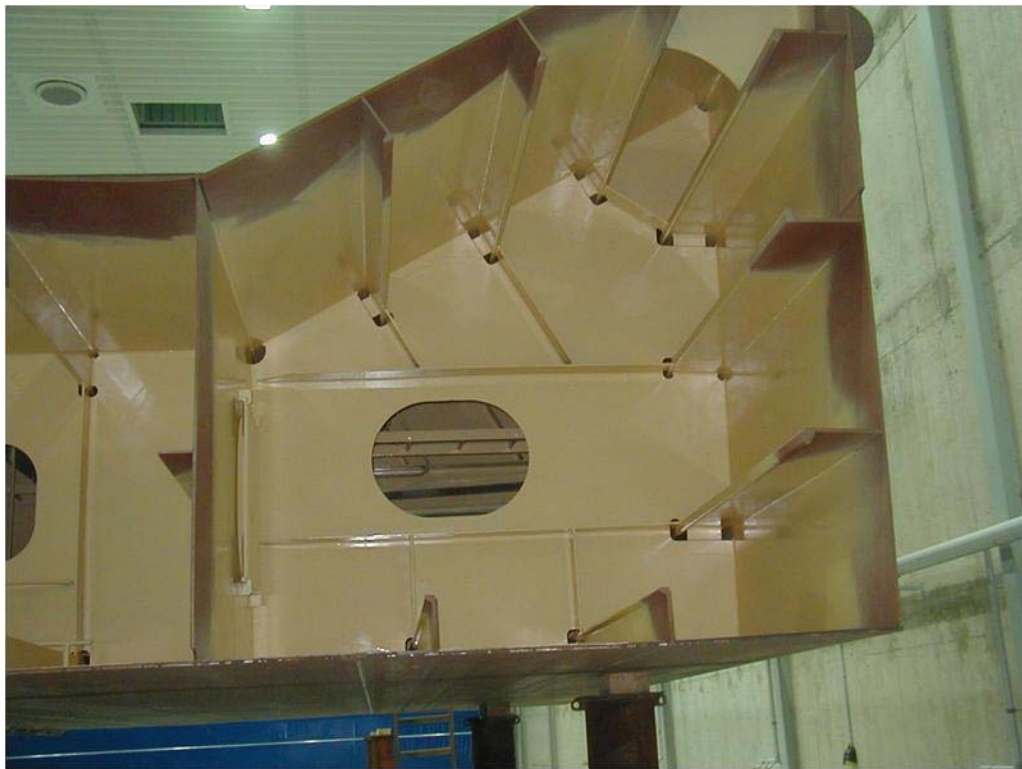
Side tank block after coating:

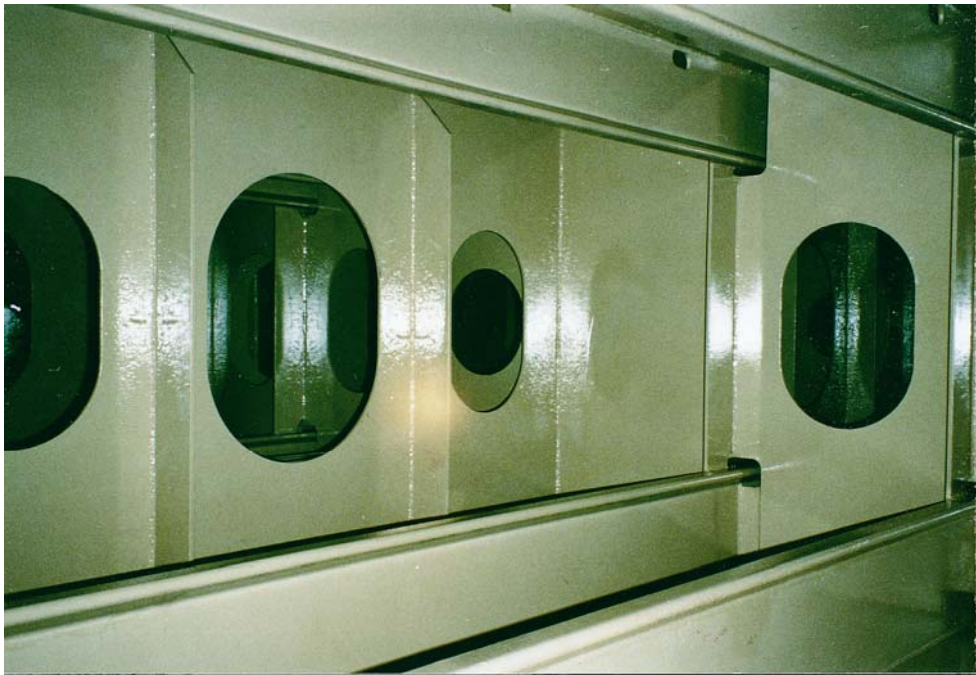
Views inside a newly coated double bottom water ballast tank:

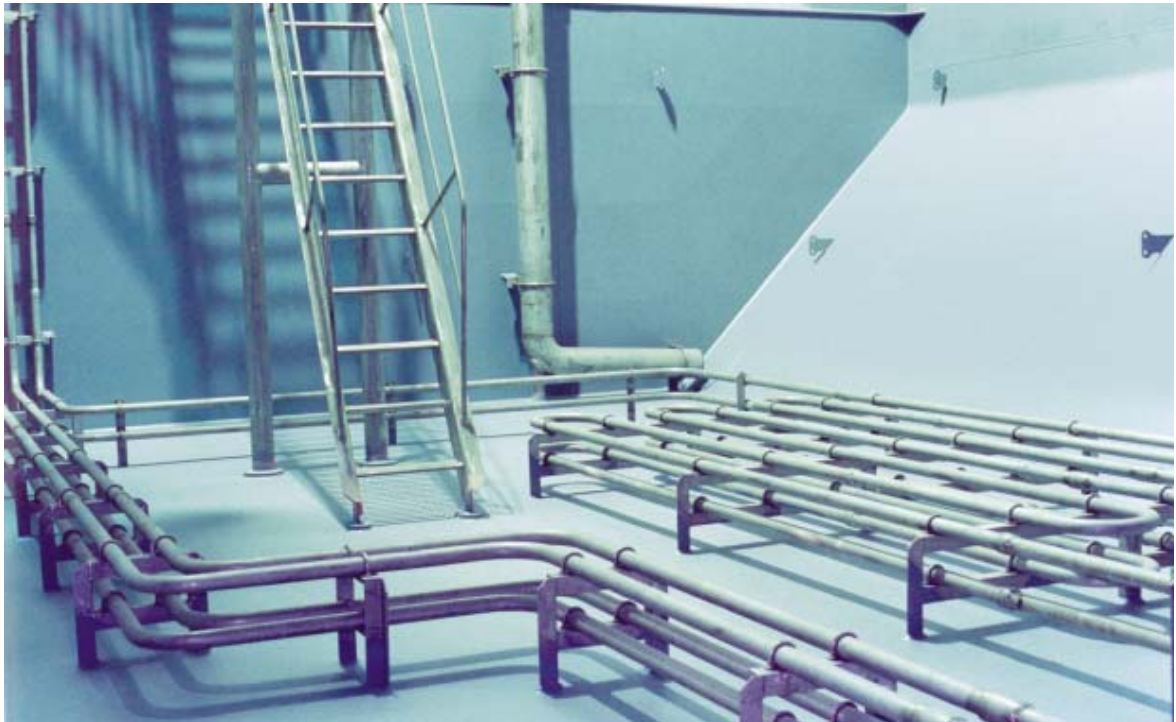
A newly coated cargo tank after completion of outfitting:

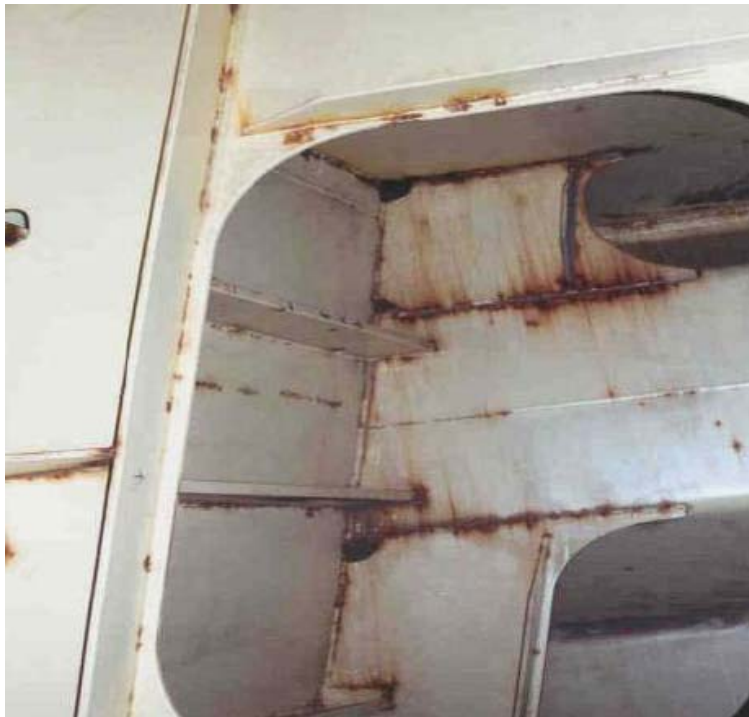
Premature coating breakdown: after 3 years of service:

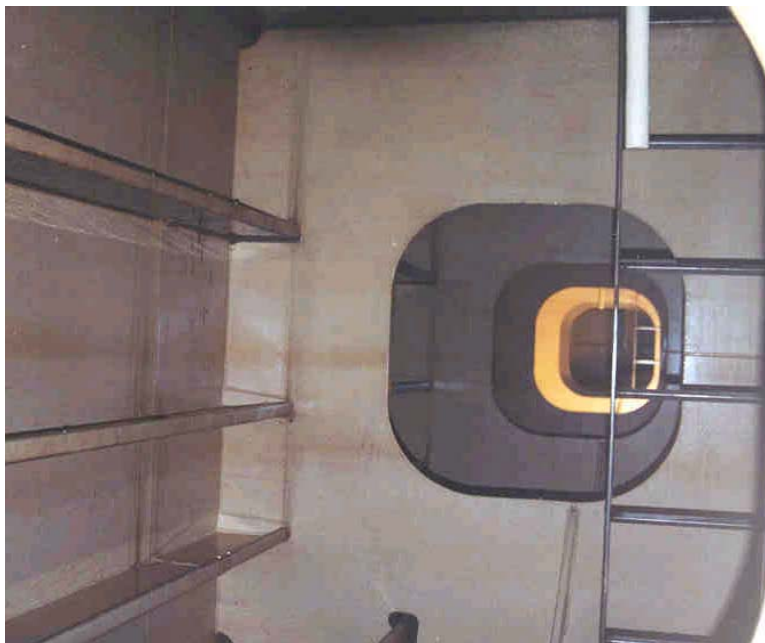
Sister ship to that shown in the previous photograph coated to a different coating specification:

- coating performing well after more than 7 years in service:

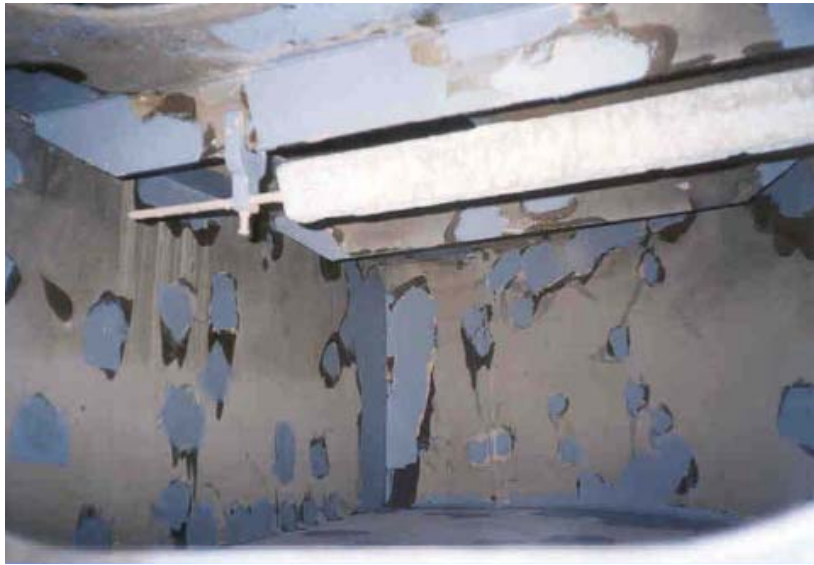
Premature coating breakdown (blistering) after 5 years of service, tank shown after touch up repairs have been carried out:

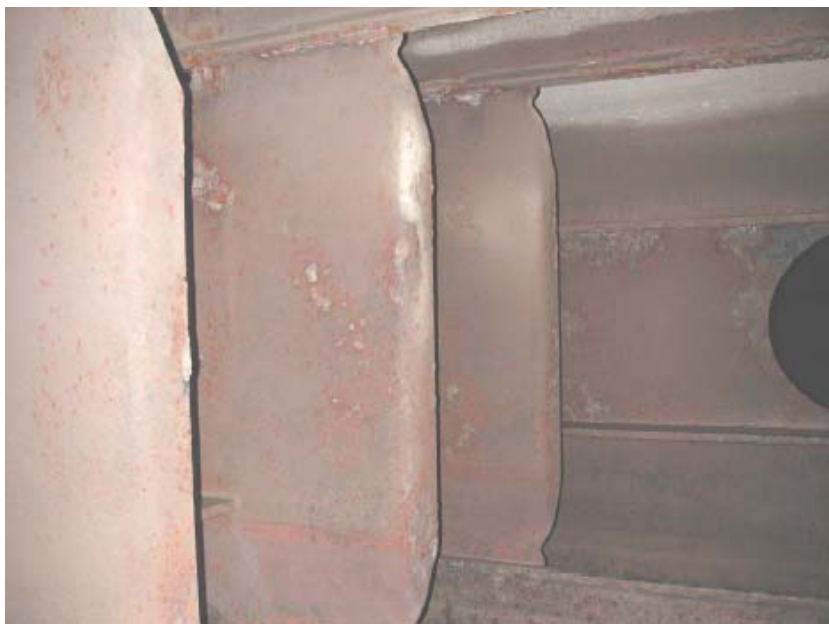
Ballast tank in which the coating system has provided steelwork protection for more than 20 years:

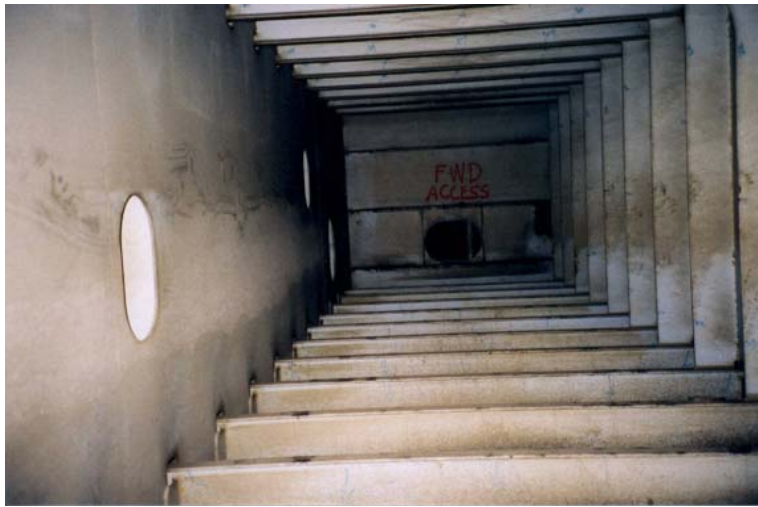
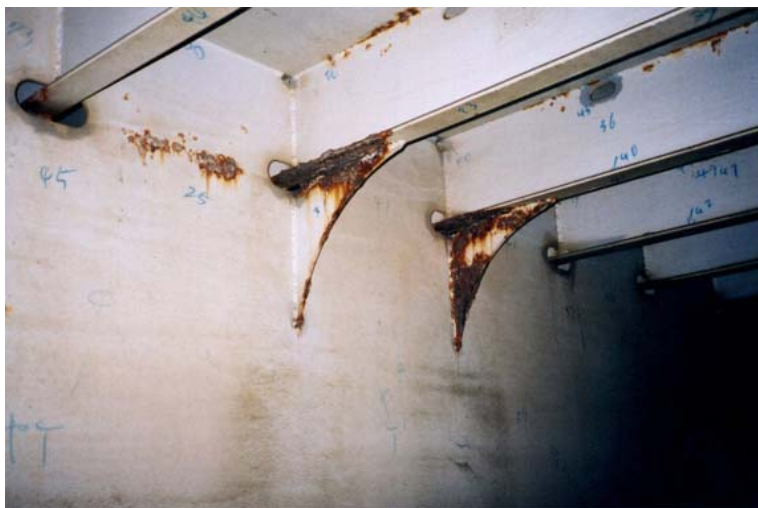
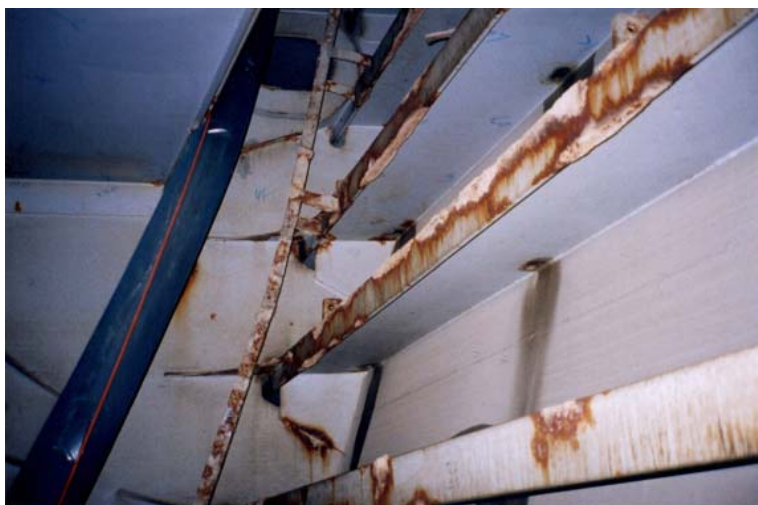
Ballast tank coatings in a double hull oil tanker after 10 years of service. The coatings have performed satisfactorily although they now need to be maintained to enable continued protection of the tank structure:

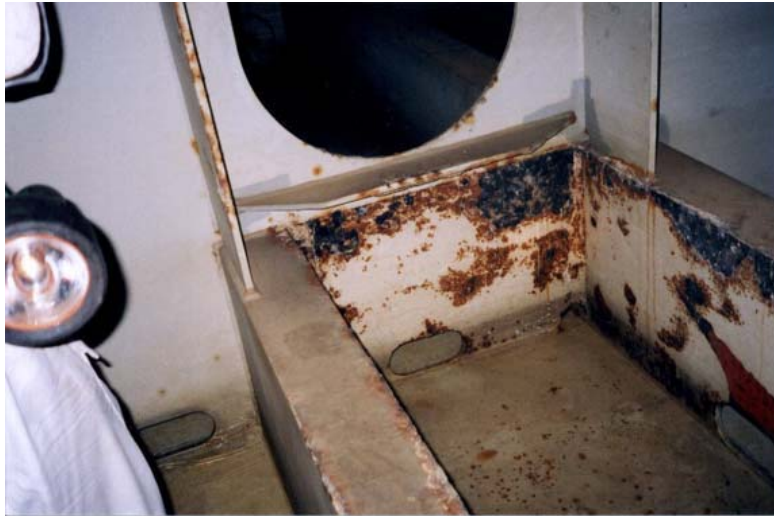
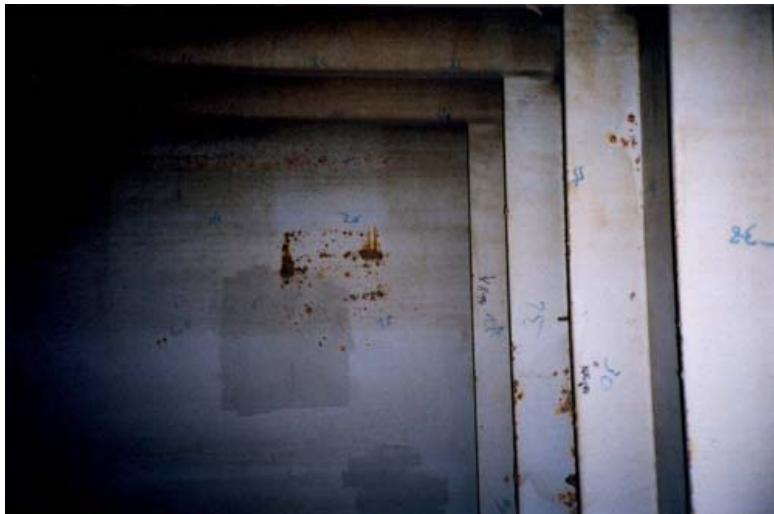
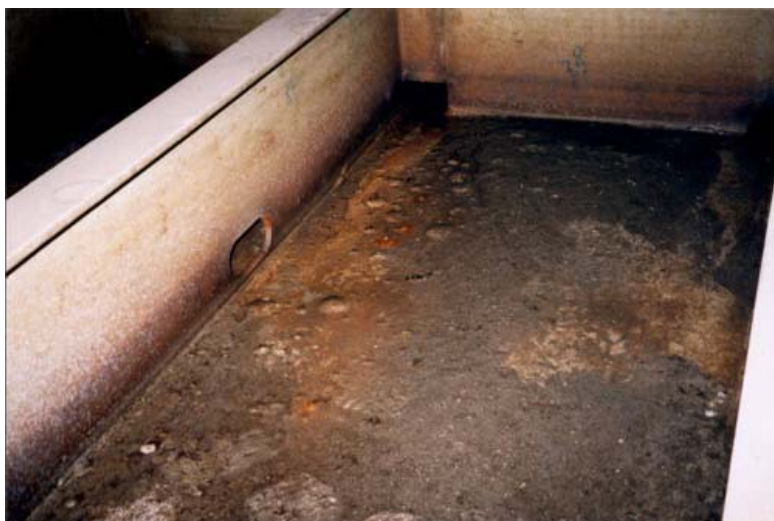
Ballast tank coatings continued:

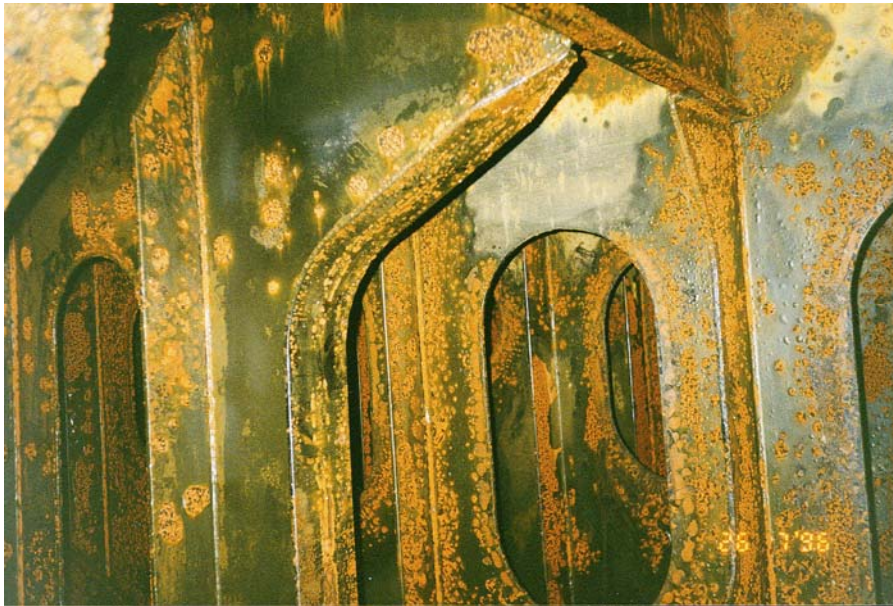
General coating breakdown without loss of structure:

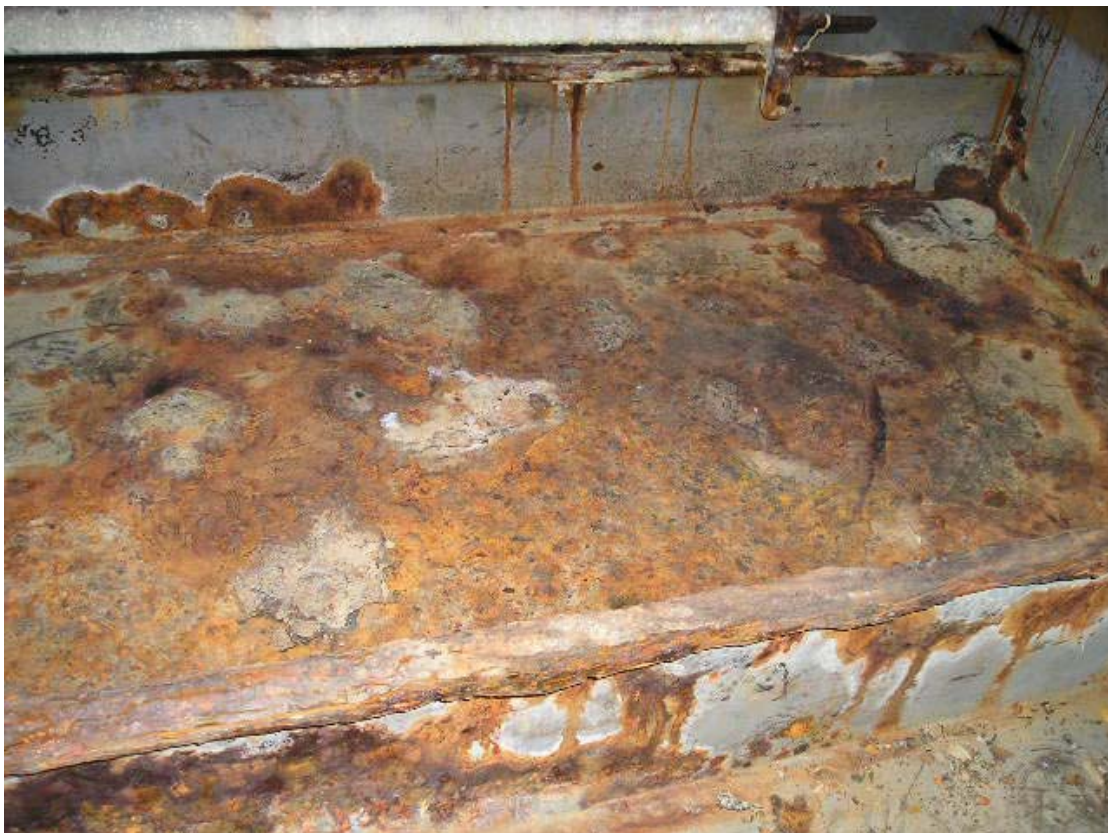
Structural loss due to corrosion:

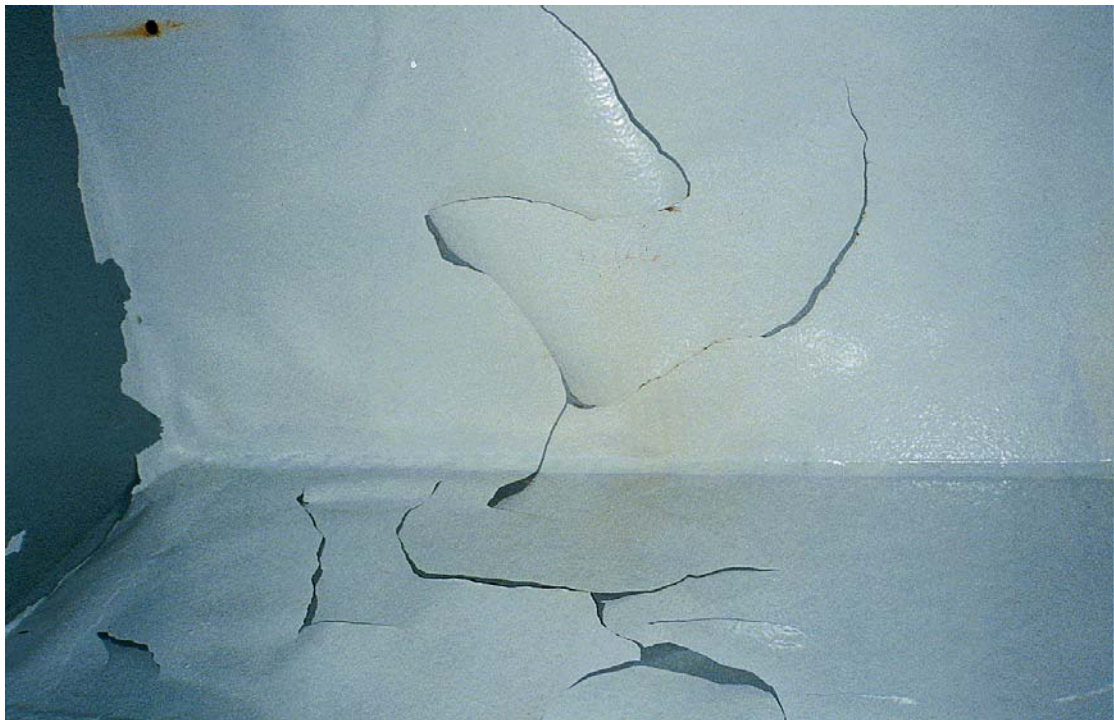
Premature coating breakdown: flaking (possibly due to excess humidity or surface contamination at the time of coating):

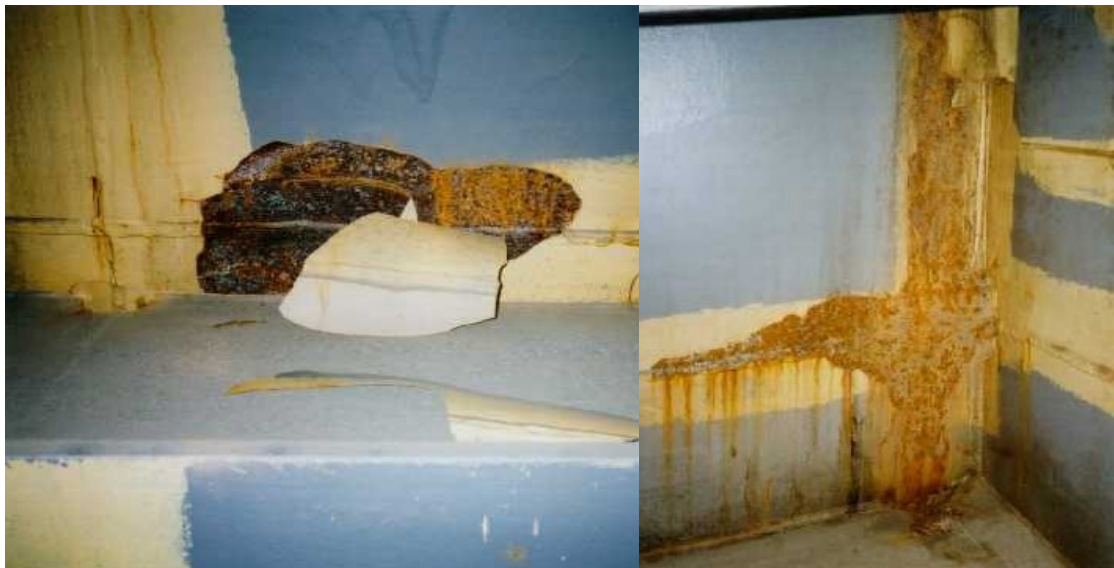
Premature coating breakdown at block erection joints, probably due to inadequate surface preparation prior to coating:
